**Traditional Reserve Study
For
Willow Wood Homeowners Association, Inc.
Dunedin, Florida
May 13, 2024**

Report Number: 2024.05.13.210

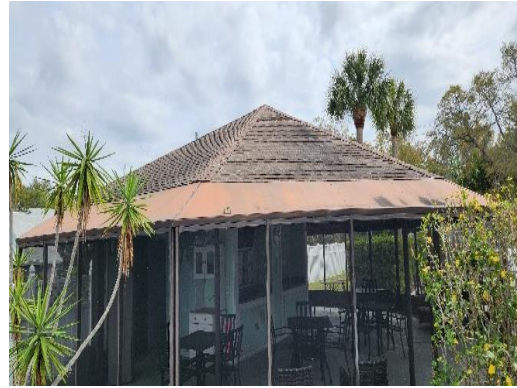
ID: 001

Item Description:
Cabana Roof

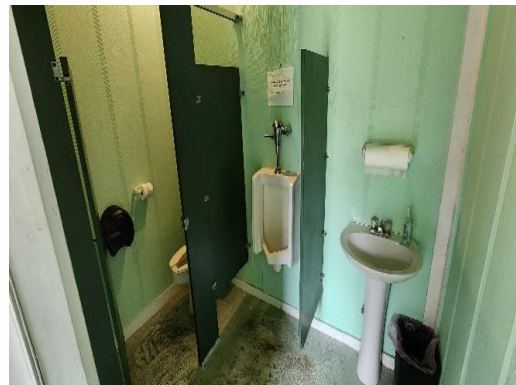
ID: 003

Item Description:
Bathrooms

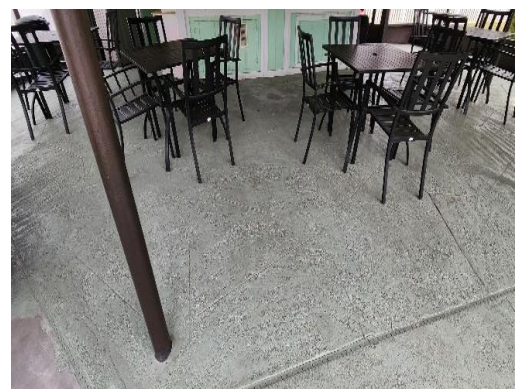
ID: 006

Item Description:
Flooring

Note: Areas of repairs noted.

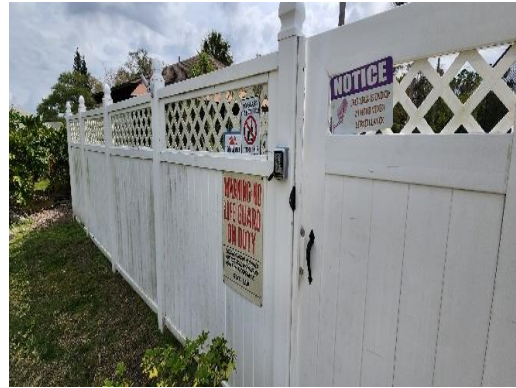
ID: 007

Item Description:
Security Cameras and Entry System

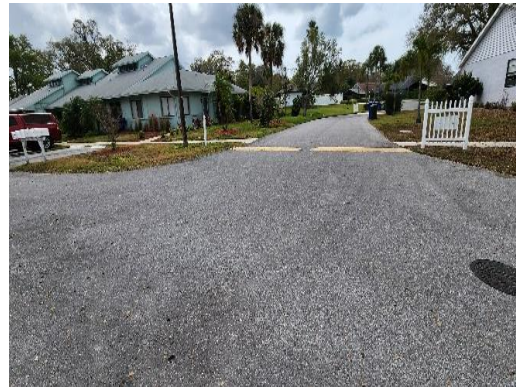
ID: 008

- **Asphalt Pavement, Mill and Overlay** – There are approximately 9,100 square yards of asphalt roads. Appears to be in fair condition.
- **Asphalt Pavement, Seal and Coat** – Seal and coat was applied several years ago to extend the useful life of the roads. No condition assessment as this product has ended its useful life.

Item Description:
Asphalt Mill and Overlay

The Association may be able to mill and overlay the asphalt pavement prior to replacement. Milling and overlaying asphalt pavement is significantly less expensive than replacement, with approximately the same useful life if the asphalt pavement is maintained properly.

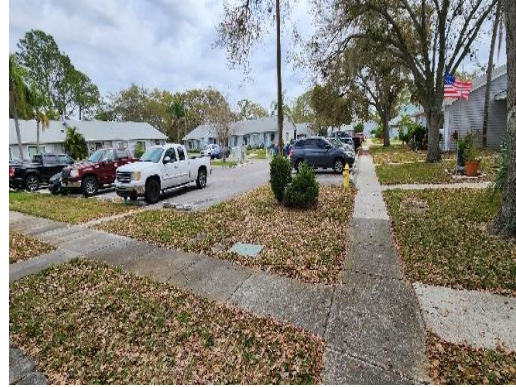
ID: 010

- **Concrete Curbs** – Concrete curbs are used to direct water off the roads and into storm drains. Good condition.
- **Concrete Sidewalks** – Concrete sidewalks and walkways for all common areas. Good condition with areas of repair and replacement.

Item Description:
Concrete Sidewalk and Walkways

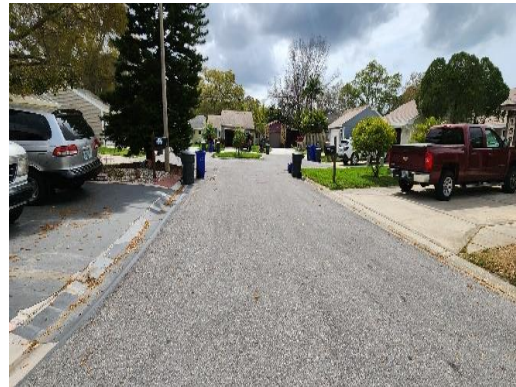
ID: 011

Item Description:
Concrete Curbs

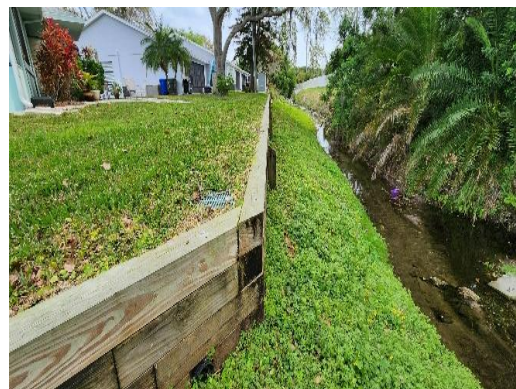
ID: 012

- **Monument Signs** – There are 2 monument signs at each entrance of the community. Fair to poor condition.
- **Retaining Walls** – Wood retaining walls built around homes backing up to the creek running through the property. Fair condition.

Item Description:
Bulkhead / Retaining Wall

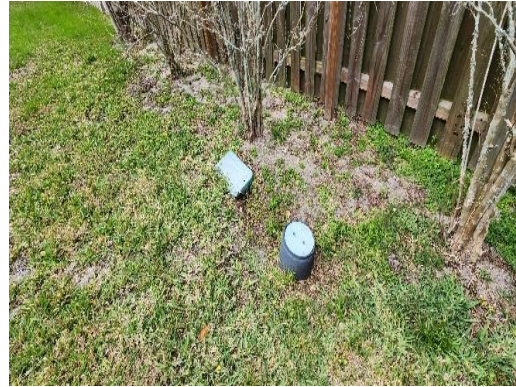
ID: 013

- **Fencing, Wood** – There are approximately 1,220 linear feet of wooden property line privacy fencing. Good to fair condition.
- **Irrigation System, Controls and Timers** – New irrigation controls, timers and lines are being ran throughout the community. Good condition.

Irrigation System, Controls and Timers

Note: This project is in process currently.

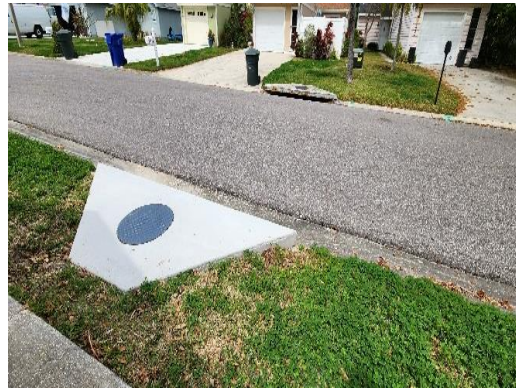
ID: 014

- **Backflow Preventor** – Backflow preventor helps maintain water pressure and keep water from flowing back to the supply side. Average condition.
- **Catch Basins** – Drainage allowance for new drain locations and repairs of old drainage areas. Good to fair condition.

Drainage

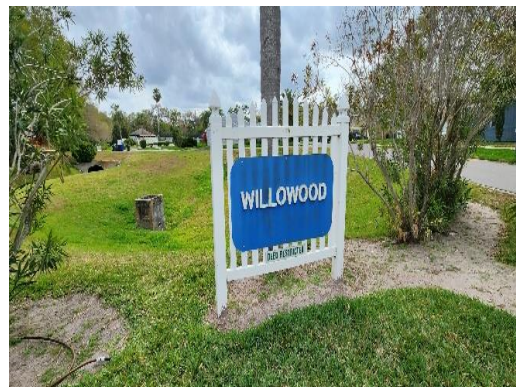
ID: 015

Monument Signage

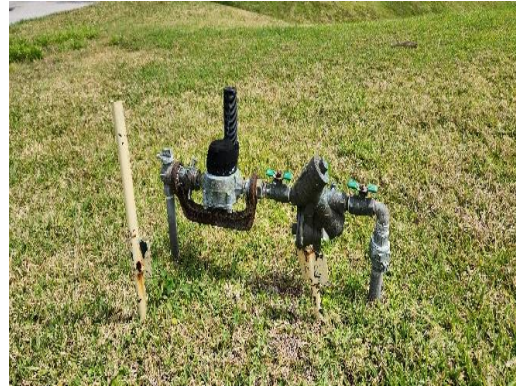
ID: 016

Item Description:
Backflow Preventor

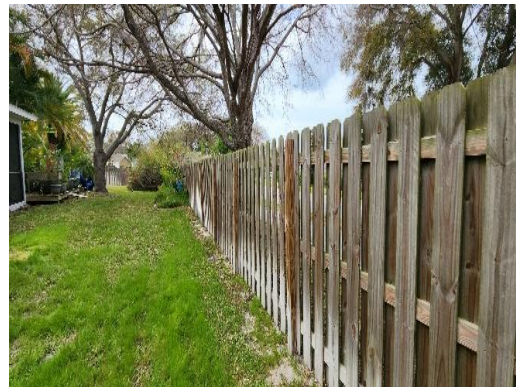
ID: 017

Item Description:
Property Line Fencing

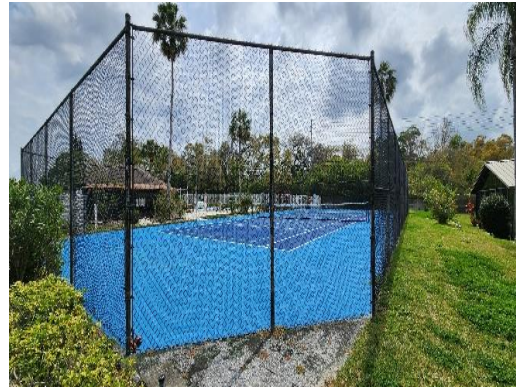
ID: 019

- **Tennis Court Fencing, Chain Link** – Tennis court fencing 10' galvanized chain link. Fair condition for age.
- **Tennis Court, rebuild** – The tennis court is original but is in very good condition for its age.
- **Tennis Court, Resurfacing** – Tennis courts recently resurfaced last year. Excellent condition.
- **Drainage Issue, One Time Expense** – The drainage issue was added at the direction of the Board of Directors. No condition assessment available.

Item Description:
Tennis Court Fencing

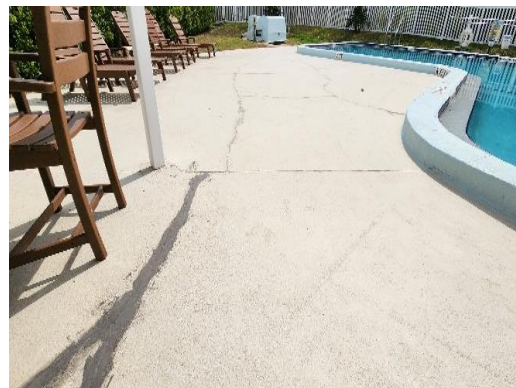
ID: 021

- **Pool Decking, Resurfacing and Repairs** – Pool decking for around the pool area. Fair condition with areas of repairs.
- **Pool Fencing** – 340 linear feet of vinyl fencing used to close off the pool and cabana area. Average condition.
- **Pool Lining and Resurfacing** – Pool lining is used to keep a water-tight seal and improve the look of the pool. Very good condition as this was refinished in 2018.
- **Pool Pumps, Electrical and Plumbing System** – This is the entire pool pump system including the electrical and plumbing system. Good to average condition with maintenance and repairs completed as needed.

Item Description:
Pool Decking, Resurfacing and Repairs

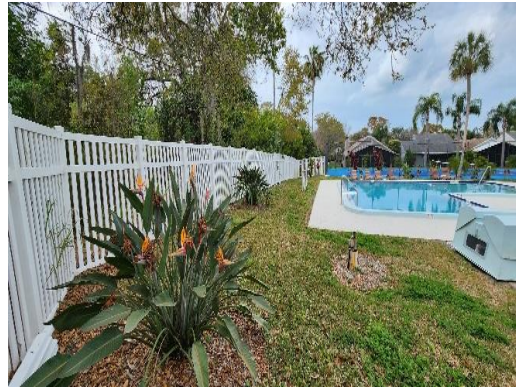
ID: 022

Item Description:
Pool Fencing
